SAS Superstructure

Daily Diary Report by Bid Item

Diary #: 171 Const Calendar Day: 420 Date: 02-Nov-2010 Tuesday

04-0120F4
04-SF-80-13.2/13.9
Self-Anchored
Suspension Bridge

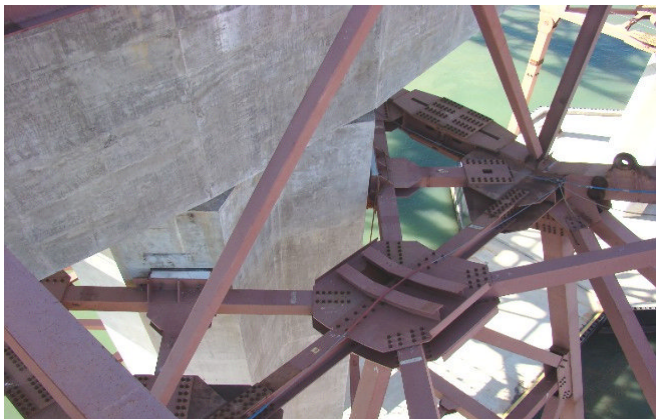
Support condition of grout between the column and the truss collar at the E2E columns on the east face, west side is similar.

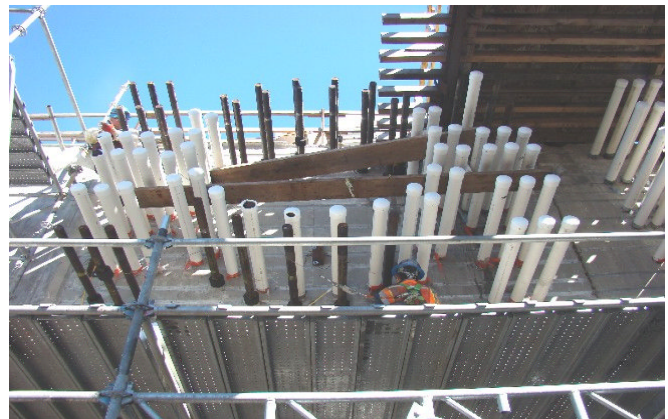
ABF laborers preparing the Macalloy rods and concrete surface for the North W2E Hinge K pipe beam assembly erection.

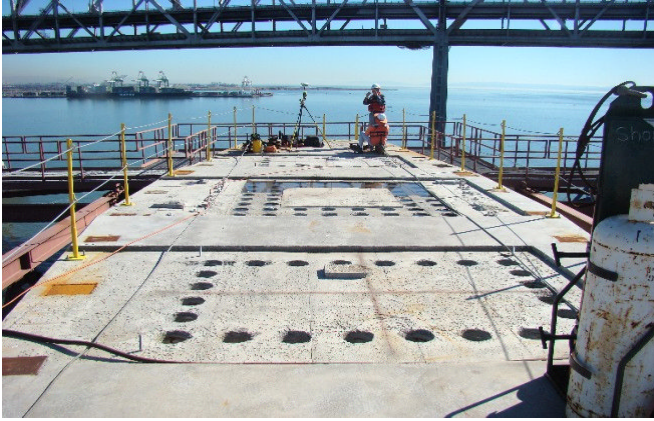
Embedded plates at the end of the E2 cap beam where the handrails will be placed and capable of folding down.

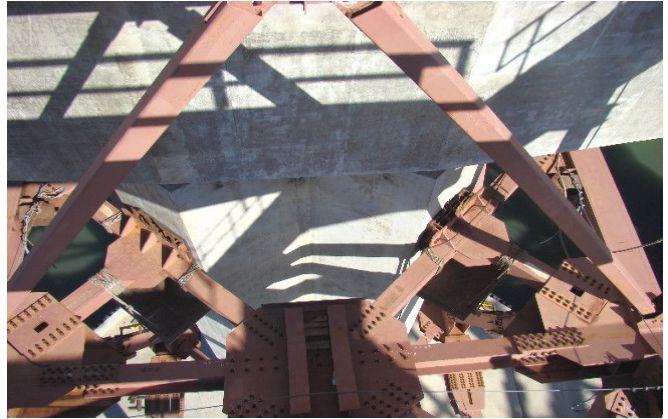
Support condition of steel I beam between the column and the truss collar at the E2W columns on the west face, east side is similar.

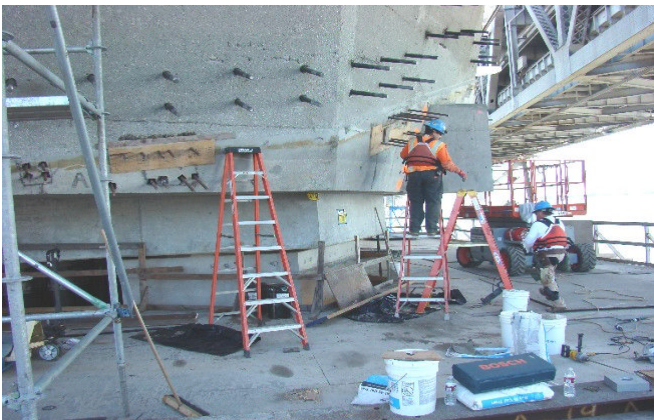
ABF laborers preparing to place grout in forms where concrete was chipped to facilitate saddle erection brackets.
